Roosevelt Residential Development Wastewater Collection System Reconnaissance Inspection

# ROOSEVELT RESIDENTIAL DEVELOPMENT WASTEWATER COLLECTION SYSTEM

Reconnaissance Inspection: Puerto Rico Aqueduct and Sewer Authority (PRASA)

Inspection Date:

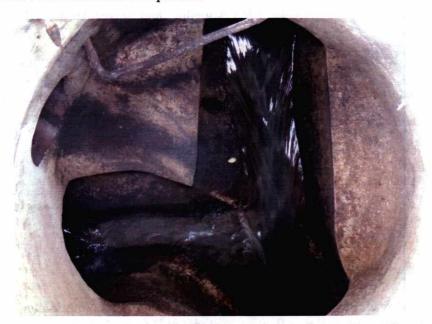
Stormwater manhole at Juan A. Dávila and Octavio Marcano Streets intersection (in front of residence #480) – Two (2) sources of dry-weather flows with wastewater characteristics were observed. The first flows from Ricardo Skerret Street and the second from Octavio Marcano Street. The amount of flow from Octavio Marcano is significant as can be observed on pictures 1 and 2 included below. This condition was also documented on our June 9, 2014 reconnaissance inspection.

Picture 1: Photo showing the dry-weather flows with wastewater characteristics described in item #1.

We need both PRASA and MSJ to inspect their respective collection system and do further investigations in this area in order to eliminate the sources of wastewater significantly affecting the storm water collection system referred above. PRASA and MSJ shall keep EPA informed about the results of the actions to be taken.

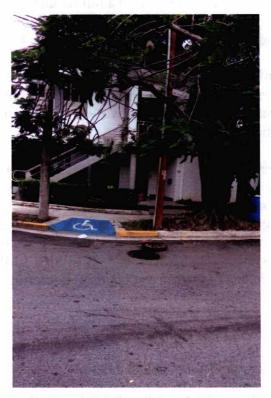
Picture 2: Stormwater manhole located at Juan A. Dávila and Octavio Marcano Streets intersection.

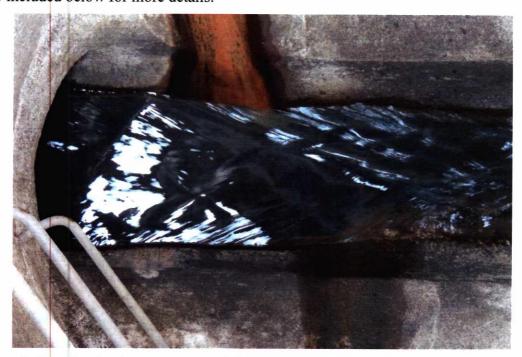
2. Stormwater manhole at Rodrigo de Triana and Octavio Marcano intersection - Significant amounts of dry-weather flow with wastewater characteristics (color, odor, and algae formation) was observed flowing in direction or from Octavio Marcano Street. See pictures 3-4 included below for more details.

Picture 3: Photo showing the stormwater manhole described in item 2 with dry-weather flow with wastewater characteristics.

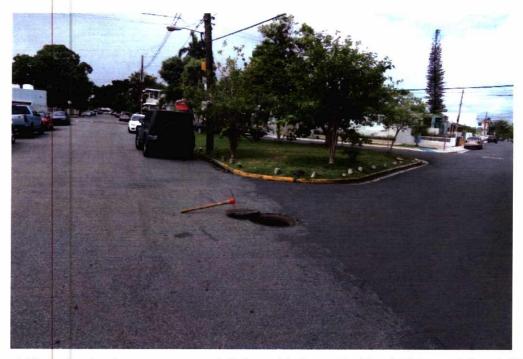
Picture 4: Photo showing the wastewater manhole located in front at Rodrigo de Triana and Octavio Marcano Streets intersection.

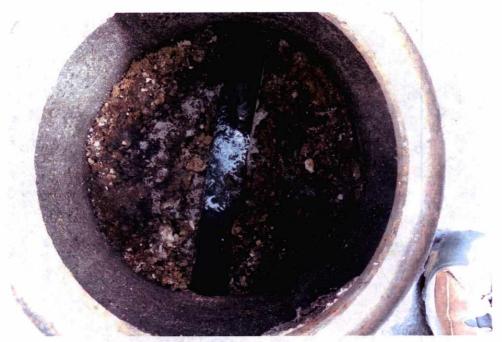
3. The wastewater manholes at Fernando Calder Street were observed flowing normally, but with significant amounts of grease and other solids accumulated on its bottom. See picture 5 for more details.

Picture 5: Photo showing wastewater manhole at Fernando Calder Street.

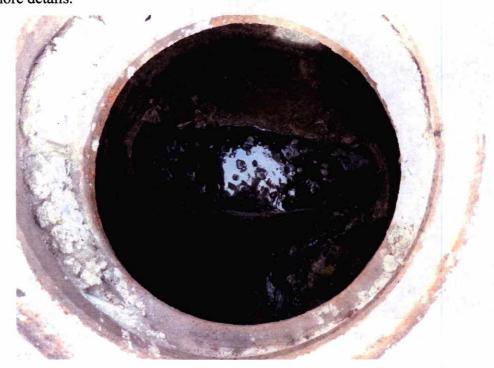
4. The wastewater manhole at Fernando Calder and Ismael Colón Street intersection was found flowing with difficulties and with sewage accumulation on its bottom. See picture #6 for more details.

Picture 6: Photo showing the wastewater manhole at Fernando Calder and Ismael Colón intersection.

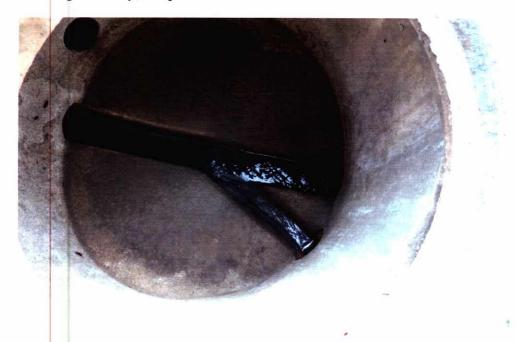
5. The waste water manhole at Fernando Calder and Octavio Marcano Streets intersection was found flowing normally, see picture #6 for more details.

Picture 7: Photo showing the wastewater manhole at Fernando Calder and Octavio Marcano intersection.
